Measuring the Effectiveness of a Tortoise-Proof Fence and Culverts: Status Report from First Field Season

William I. Boarman, Marc Sazaki, Kristin H. Berry, Gilbert O. Goodlett, W. Bryan Jennings and A. Peter Woodman

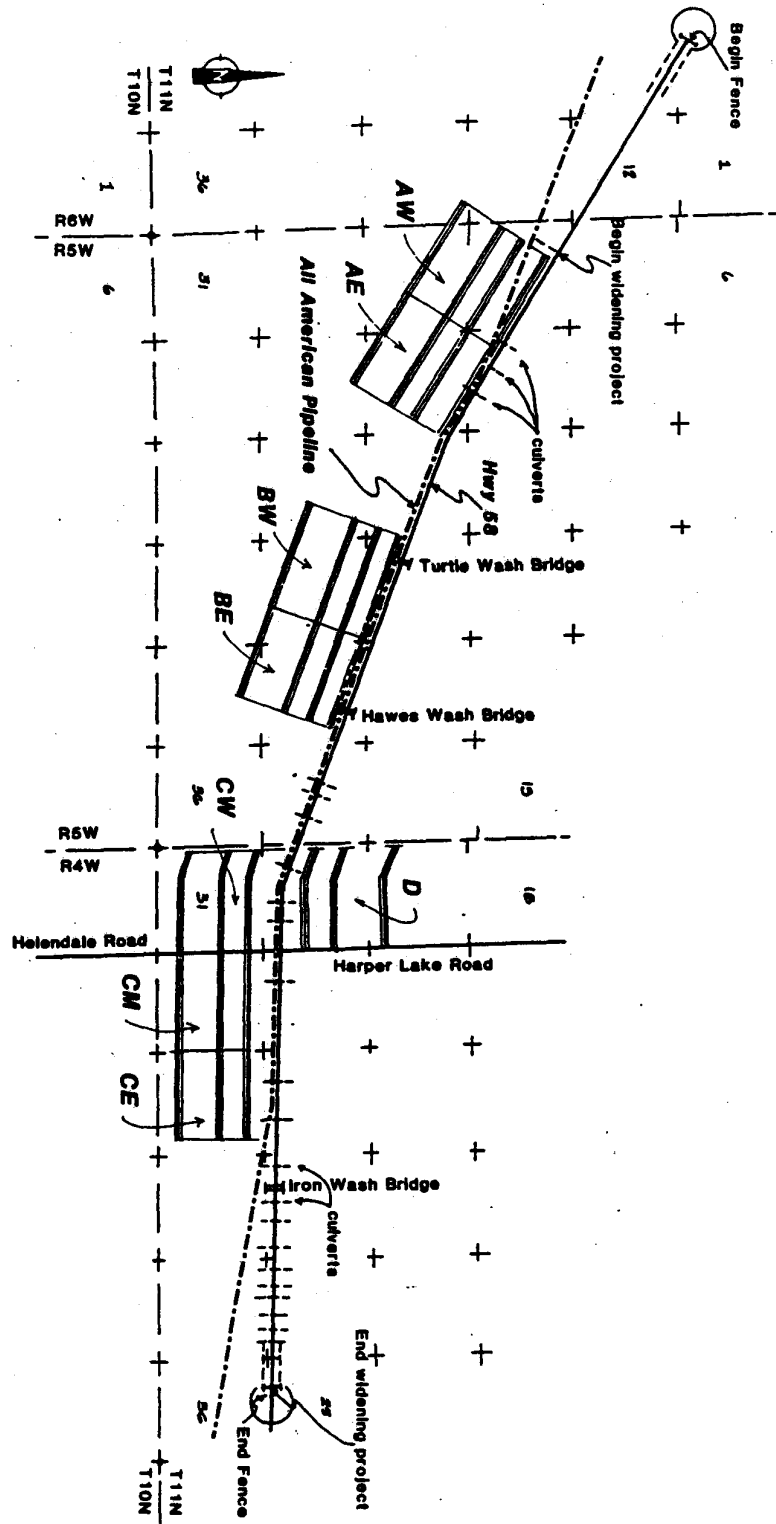
Figure 1. Map showing potential study sites that were surveyed by strip transects for estimates of tortoise density and human impacts.

The highway traverses slightly rolling terrain consisting primarily of shadscale scrub and creosote bush scrub communities at elevations of 2245 to 2470 ft. The tortoise-proof portion of the fence consists of 24-inch wide, 1/2-inch hardware cloth sunk generally 6 in beneath ground level. The hardware cloth is attached to a 5-ft high, 5-strand right-of-way fence with three barbed wires on top and two un-barbed wires below. The 156 to 206 ft. long culverts are made of 36 to 60 inch, corrugated metal pipe; 54 inch, reinforced concrete pipe; or 10 ft to 12 ft by 6 ft to 10 ft, reinforced concrete boxes. The culverts cross beneath the entire width of the highway and will eventually connect directly to the fence, thus providing an unobstructed pathway between both sides of the fenced highway (Fig. 1).

Methods.--Surveys were conducted for tortoise sign and human impacts between March 20 and 31, 1991. The surveys consisted of a series of strip transects, which were each 10-yds wide and ran the width of each site, parallel to the highway. For each site there were four sets of three contiguous transects (Fig. 1). One set began immediately adjacent to the fence or pipeline right-of-way where it abutted the fence, the second was centered 1/4 mile from the fence, the third 1/2 mile, and the fourth ended 1 mile from the fence.

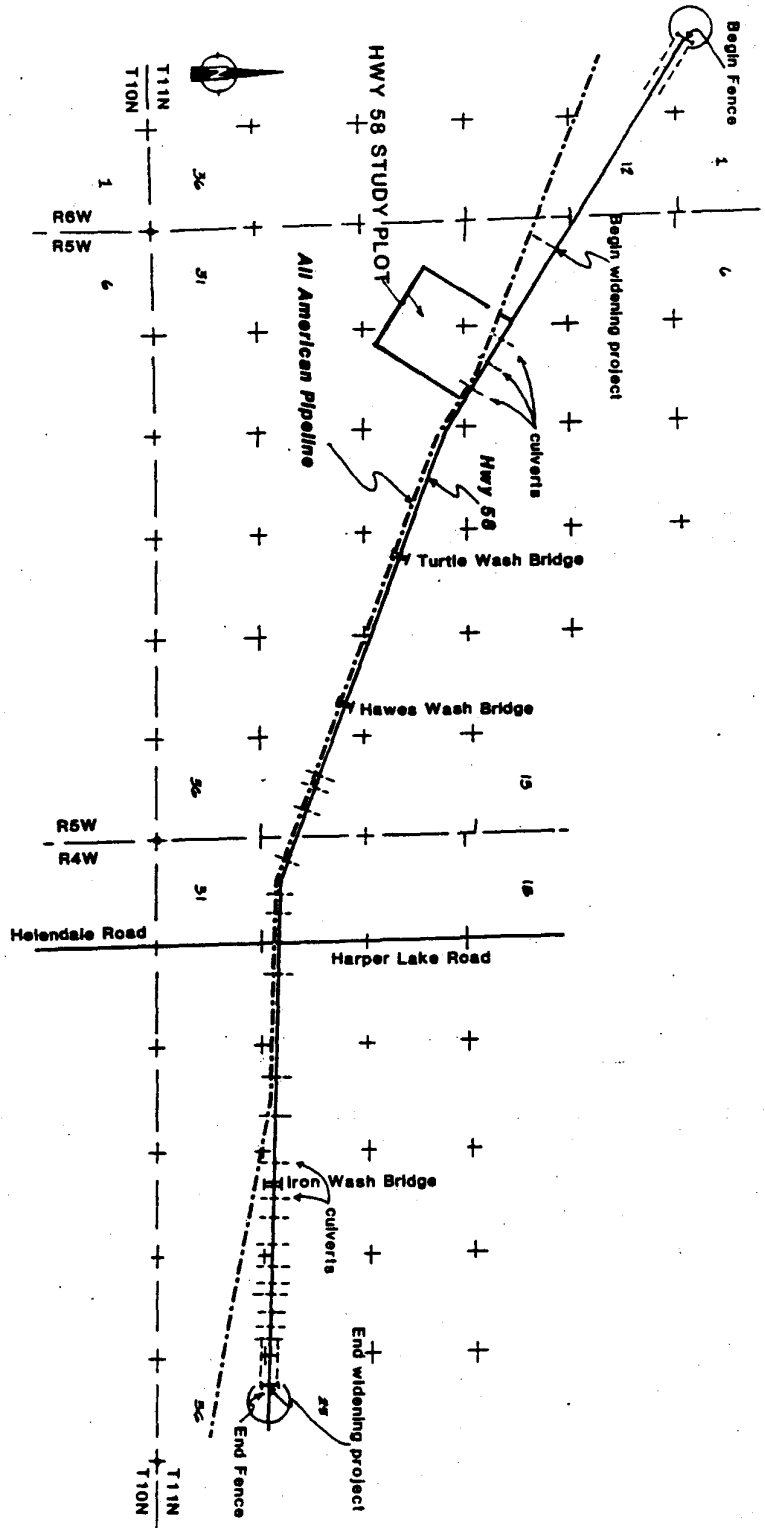
Figure 2. Map of general location of study plot.

The selected study plot is a combination of study sites AE and AW (Fig. 2). It contains three culverts (two round corrugated metal ones and one large, double, concrete box culvert), has a relatively low level of human impacts, exhibits moderately heterogeneous habitat, is sufficiently large to contain a 1 mi² study plot with room for expansion, and is easily accessible for field workers. The All-American Pipeline does skirt the edge of the fence at the northeast end of the site, which may confound the study, but this was also true of all other marginally acceptable sites. The site includes a portion of the low density site AE, but was extended as far as was possible into site AW, which had an intermediate tortoise density. If feasible, the boundaries of the plot will be extended in the future to incorporate more of the higher density tortoise habitat and is less confounded by the All-American pipeline.

The study plot is located on the south side of Hwy 58, approximately 7 miles east of Kramer Junction, San Bernardino Co., California (Fig. 2). It consists primarily of rolling hills to the north and relatively flat areas to the south. Vegetation is primarily an association of creosote bush (*Larrea tridentata*), burrobush (*Ambrosia dumosa*), Mojave saltbush (*Atriplex spinifera*), and Anderson thornbush (*Lycium andersonii*). Creosote is predominant in the northern portion of the study plot and saltbush dominates in the south. A small dry lake bed occurs at the southeast corner of the plot. The plot's substrate primarily consists of coarse sand or gravel with patches of cobblestone in the north and sandy loam in the south.

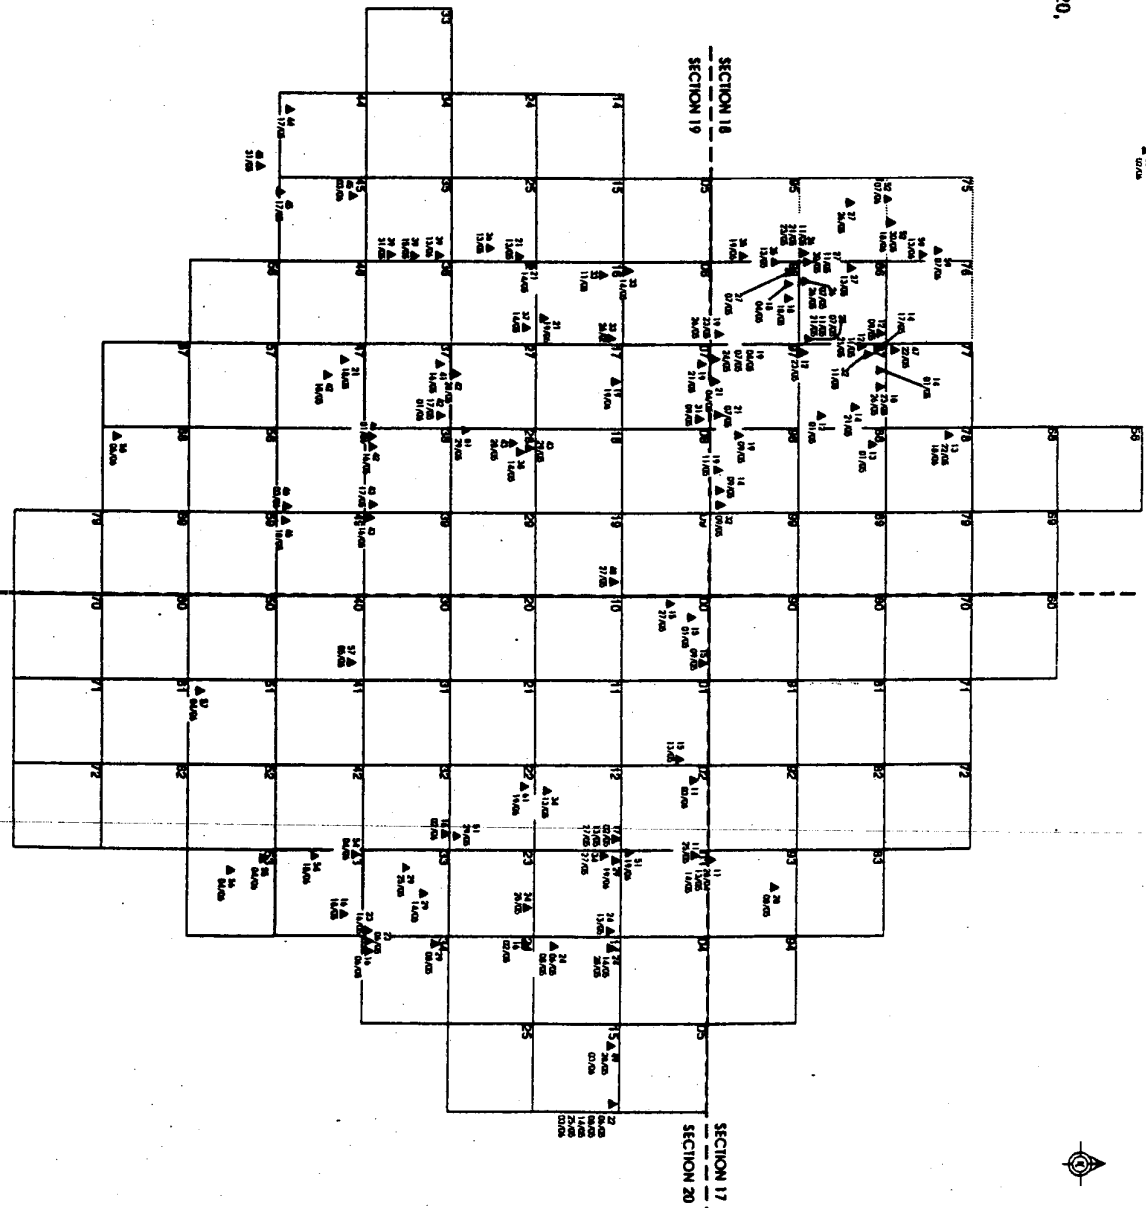
Figure 3. Map showing the layout and numbering system of plot grids and showing all individual tortoise sightings within or near the study site in spring of 1991.

On May 3, 1991, the 1 mi² study plot was surveyed and a grid system established that was identical to that used at other BLM permanent study plots (Fig. 3). The northeast boundary of the site was along the highway barrier fence with the sides running at 90° angles southwest for one mile. The plot was surveyed relative to the legal cadastral survey for the area using range poles and reflecting prisms, which reflect infrared light back to the instrument giving a very accurate, distinct measure. A compass bearing, corrected for declination and accurate to 0.25°, was used as a reference angle. A total of 100 quadrats, which were each 528 ft X 528 ft, were surveyed and marked. For marking each quadrat, a four-foot length of 3/8-in rebar was placed in each corner. Ten-ft long 1/2-in diameter, Schedule 125 PVC pipe was placed over each rebar. The quadrats were numbered from 00 in the NW corner of each cadastral section (Fig. 7) and the quadrat number was written on the pole at the northwest corner of each quadrat. An additional five off-plot quadrats were established in the northwest corner where tortoise densities were higher.

In all, 47 tortoises were located, 44 of which were on the actual study plot (Table 2). Of those 47, 10 were adult females, 8 adult males, and 29 were too young to determine sex correctly. Four animals had wet "beaks" or noses, both of which are possible signs of Upper Respiratory Tract Disease. Three of them were of normal weight for their sex and size, while the fourth was somewhat lighter than expected. Locations of each individual sighting of live tortoises are shown in Fig. 3 and locations of the 65 tortoise carcasses found are shown in Fig. 4.

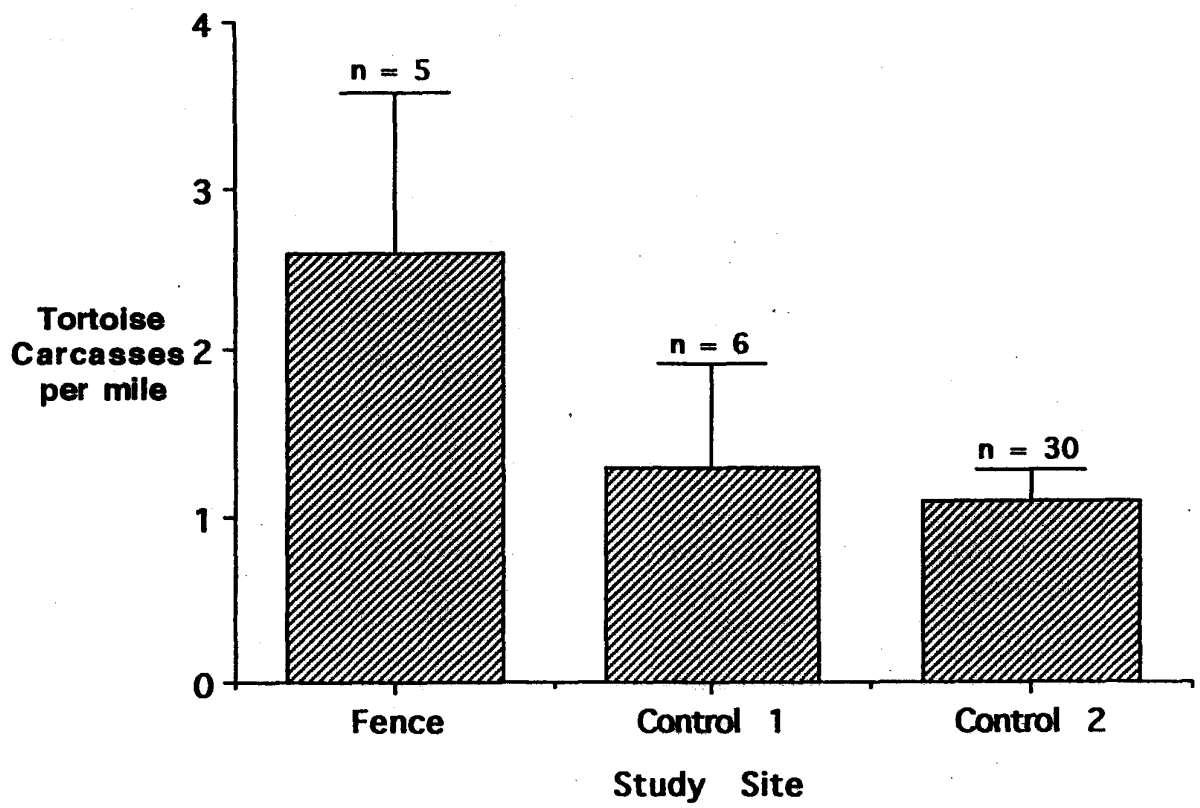
Figure 7. Mean (+ 1 SE) number of shells found per mile along highway edges.

The mean number of shells found per mile in the Treatment site (2.6 ± 0.980) was roughly twice that found in each of the Control sites (1.3 ± 0.615 and 1.1 ± 0.182 ; Fig. 7). However, the variance among transects within each site was so great that there was no significant difference among sites (Kruskal-Wallis $H_c = 2.277$, $df = 2$, $p = 0.3202$).

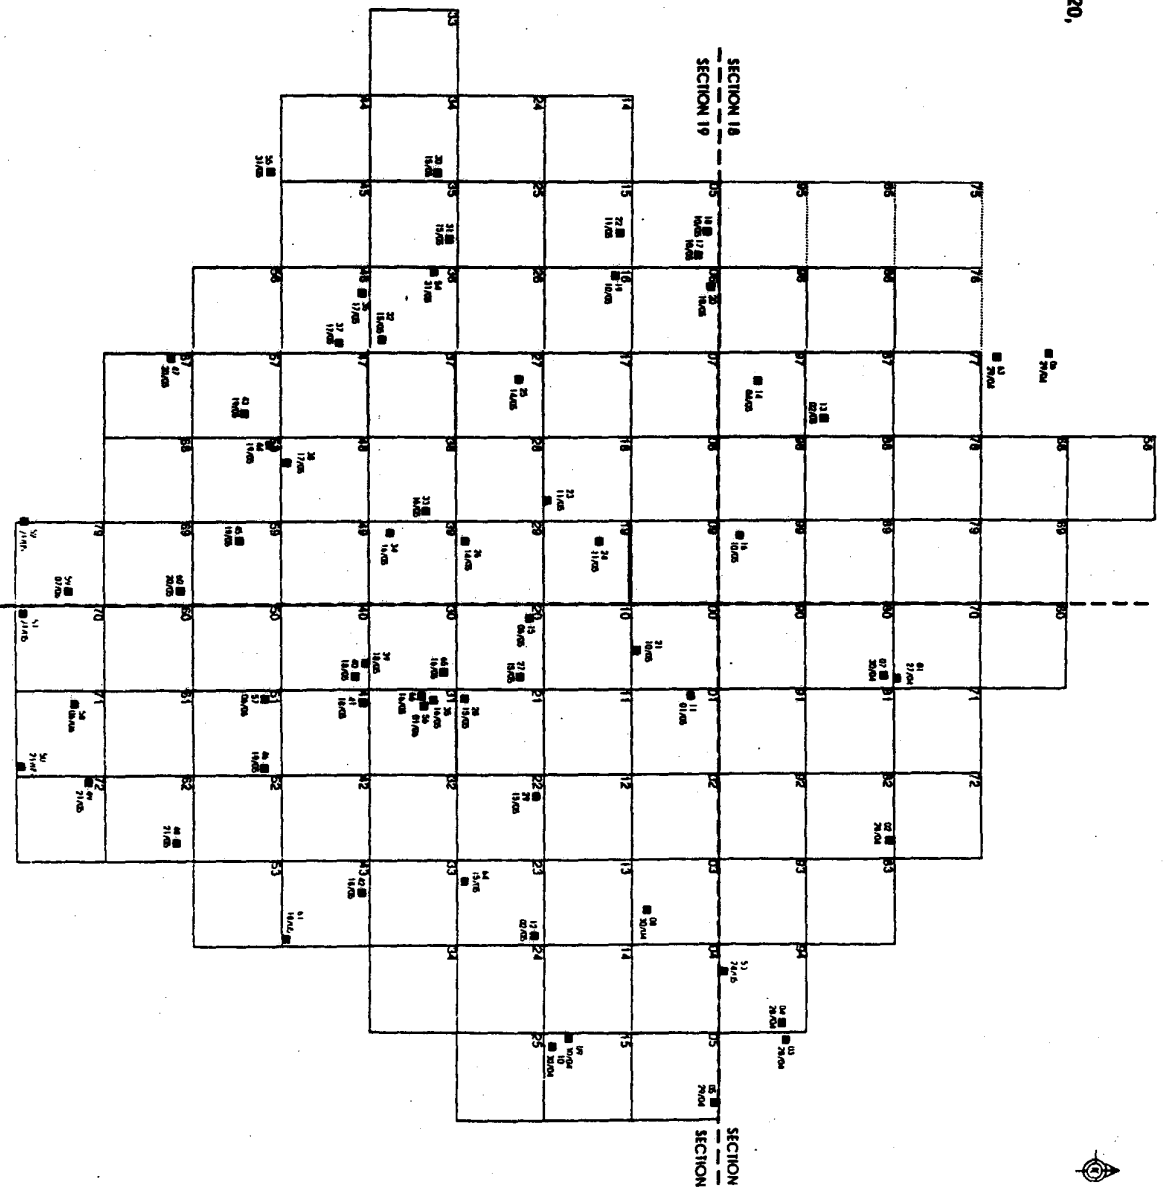
Figure 4. Map of all locations of all tortoise carcasses found within or near the study site in spring of 1991.

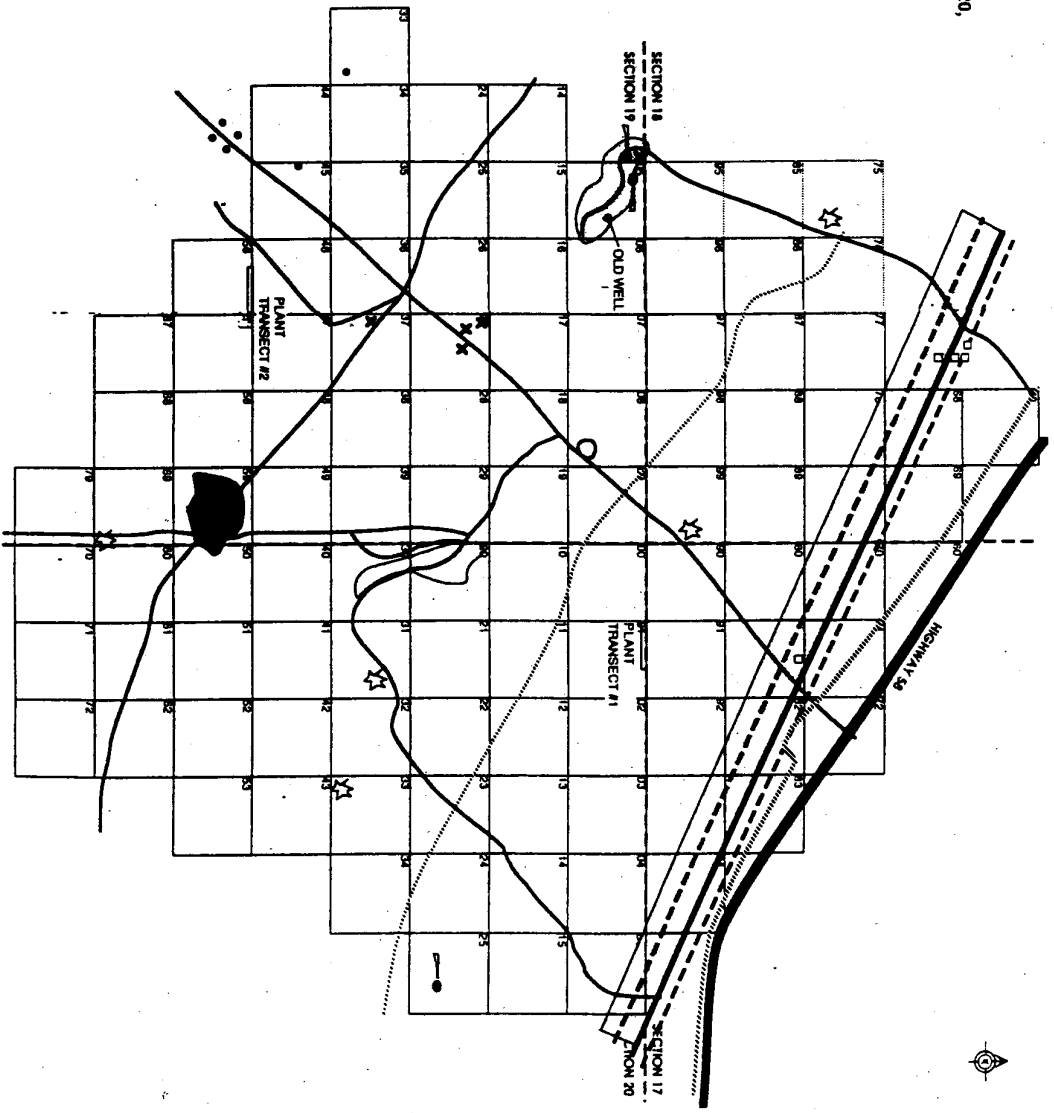
Figure 5. Map of major human impacts recorded on the study plot in spring of 1991.

Several human impacts were present on the site (Fig. 5). The majority of the plot lies south of the All-American and Mojave gas pipelines, but the pipeline right-of-way runs directly through the north-east end, mostly parallel to the barrier fence. Five lightly traveled, dirt access roads run through the plot, although none were known to be used by anyone not associated with this project. A helicopter and patrol plane flew low over the plot on daily inspections of the pipeline. The plot has been subjected to sheep grazing in the past; dry sheep manure was found within 10 of the plot's 100 quadrats. Several mining pits and balloon remains were found scattered throughout the plot. Evidence of shooting included shotgun shells and clay pigeons in two quadrats. Beer cans and a few broken bottles were found within tossing distance of the highway although there were also many scattered throughout the plot. Campsites with old fire pits were found on four quadrats.

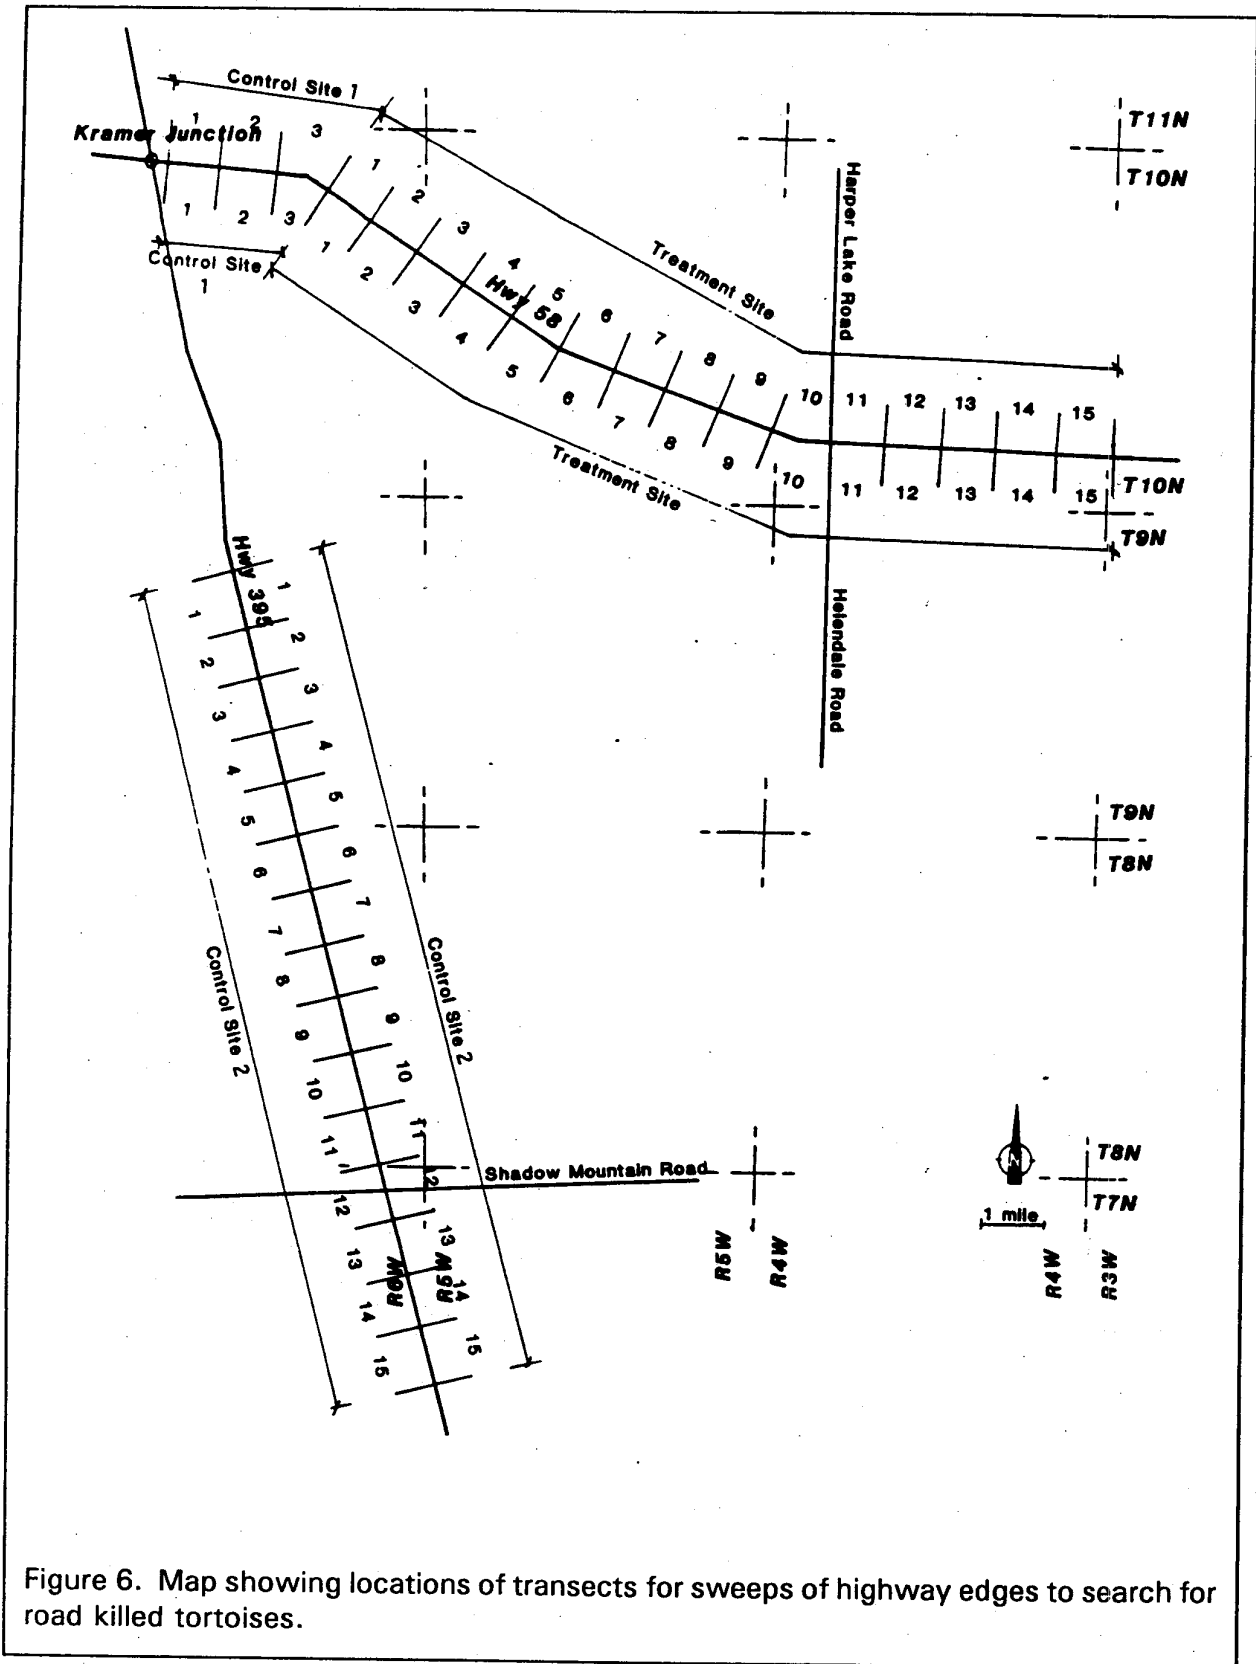
Figure 6. Map showing locations of transects for sweeps of highway edges to search for road killed tortoises.

Between February 22 and March 12, 1991, 66 1-mi transects were surveyed along both edges of Hwy 58 and Hwy 395, east and south of Kramer Junction, San Bernardino Co., California (Fig. 6). The general study area was subdivided into three sites: Treatment, Control 1, and Control 2. The Treatment site consisted of both sides of Highway 58 where the tortoise-proof fence was in place. It began approximately 3.6 miles east of Kramer Junction and extended east for 15 miles (30 1-mile transects). Control 1 was along a nearby section of Hwy 58 without a tortoise-proof fence. It began at the western-most end of the Treatment site and ran west along both sides of the highway for three miles (6 1-mile transects). Control 2 was along an unfenced section of Hwy 395. It began 7.7 mi south of Kramer Jct and ran south for 15 miles along both sides of the highway (30 1-mile transects).
